REPORT**3933 US ROUTE 11 CORTLAND, NEW YORK 13045**

REPORT NO. 104614794CRT-001b**STATIC PRESSURE VERSUS AIRFLOW
AND SOUND POWER LEVEL TESTS ON A
2 X 4 RETURN AIR LIGHT TROFFER****RENDERED TO****TADD, LLC
188 S. NORTHWEST HIGHWAY
CARY, IL 60013****INTRODUCTION**

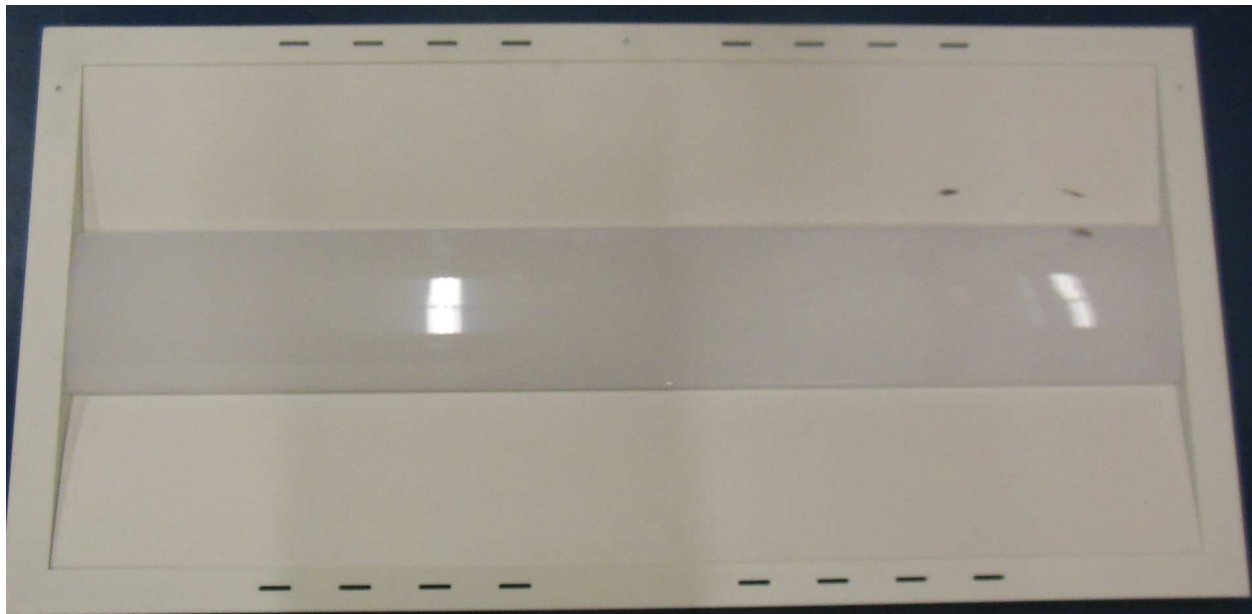
PHOTOGRAPH OF TEST SAMPLE

The sample consisted of a 23 $\frac{3}{4}$ inch wide by 47 $\frac{3}{4}$ inch long by 1 $\frac{3}{4}$ inch light troffer with eight 1 $\frac{1}{4}$ inch long by $\frac{3}{16}$ inch wide air return slots on opposite long sides. The sample was constructed from aluminum. The testing was done in the return air direction using isothermal air.
